**MARILOY S-400 Pipes,  
1%Cr Steel for  
Cargo Oil and Water  
Ballast Pipes**

**Nippon Steel Corporation**

**Investigation of  
Mariloy Pipes used  
in a tanker for a Long Time**

Tanker Name: TOHZAN (ex-COSMO ASTREA) /Kyoei Tanker

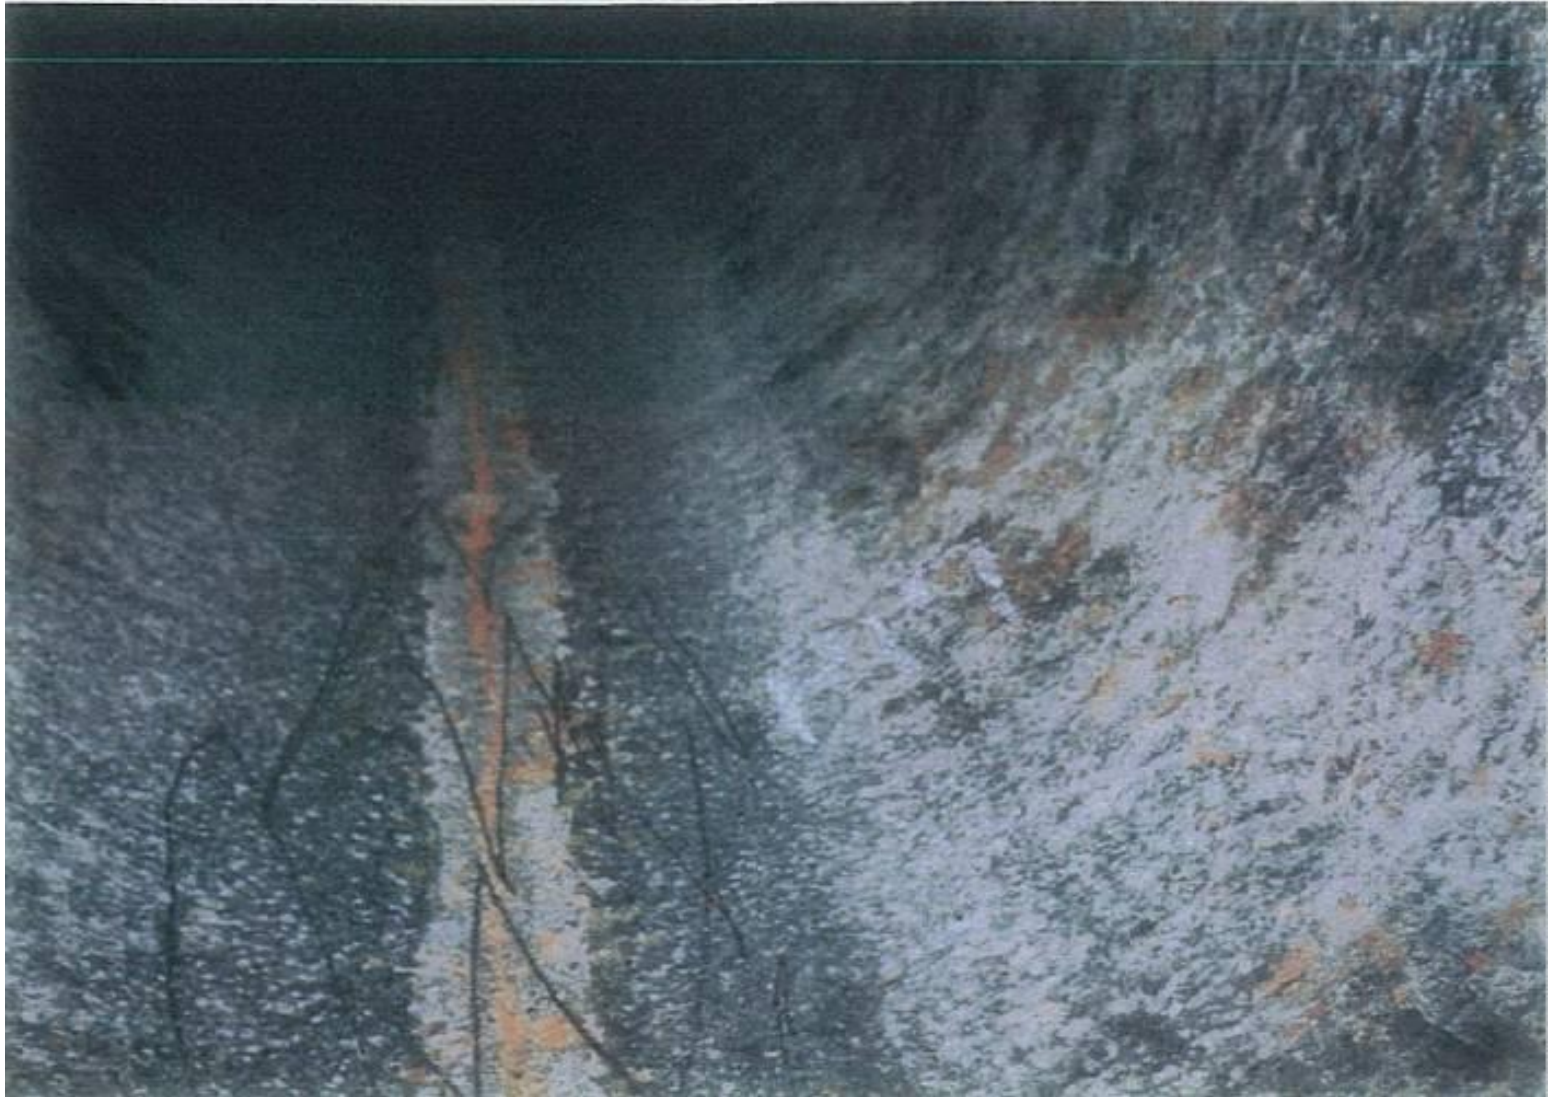
# Inside of Cargo Oil Pipe After 12.5 Years

The corrosion product is close to that usually observed in cargo oil carbon pipes and tanks, except the existence of Cr. The good corrosion resistance of Mariloy pipe may come from Cr-containing oil coat.

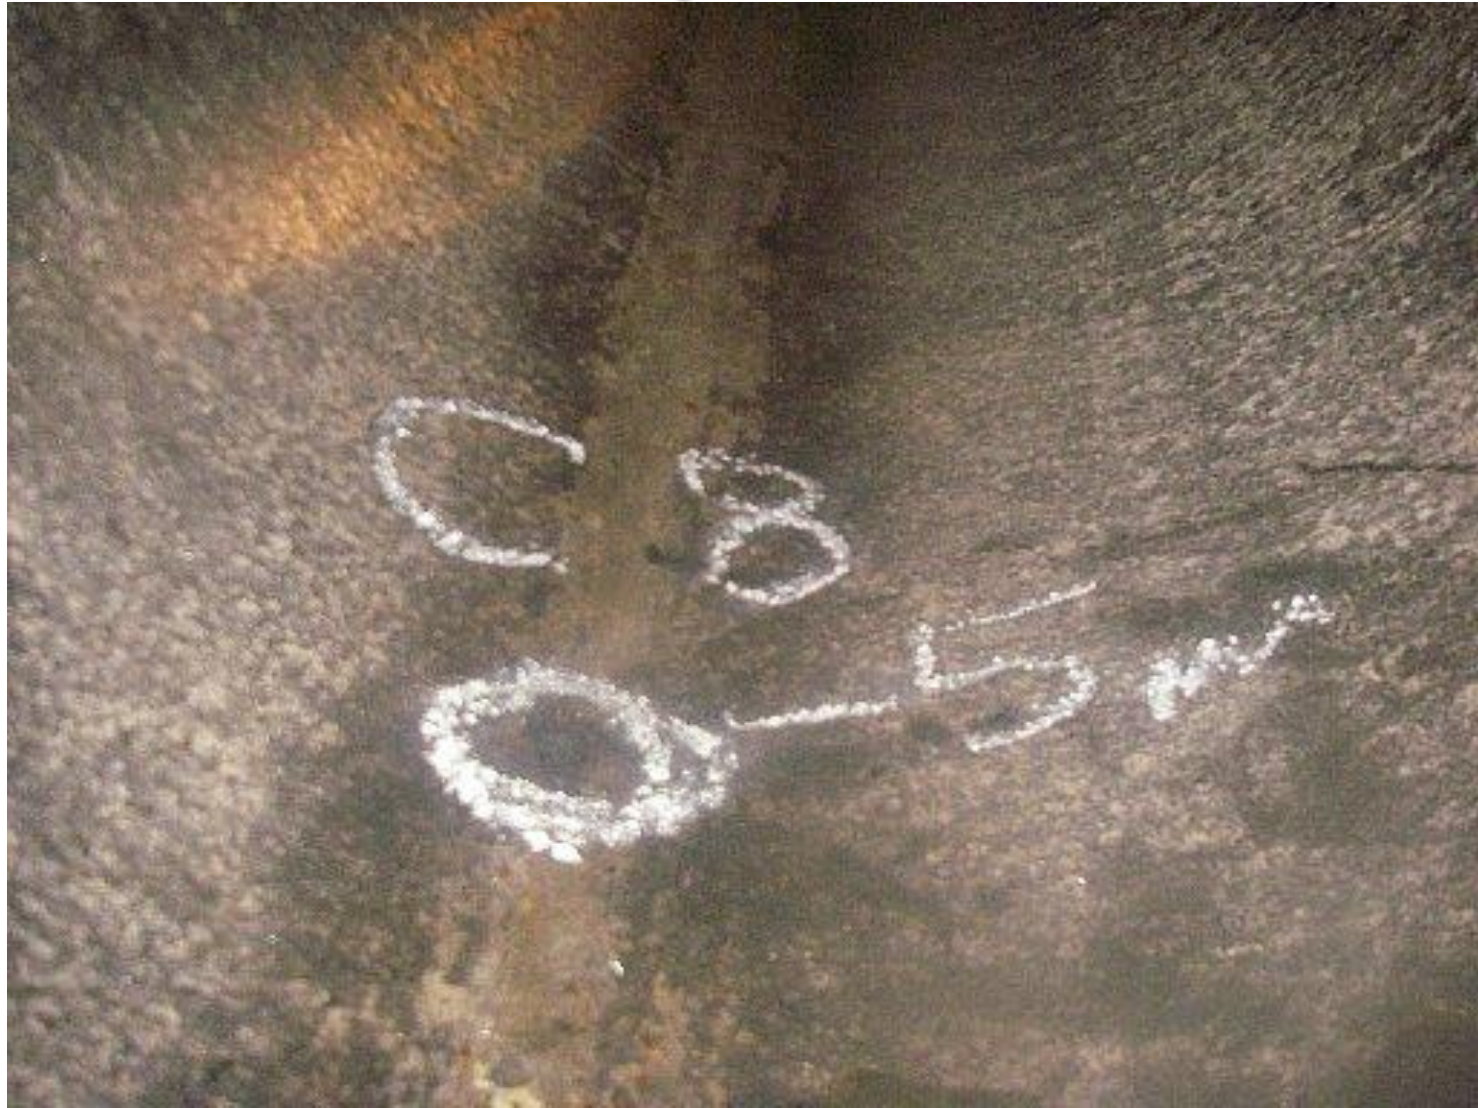
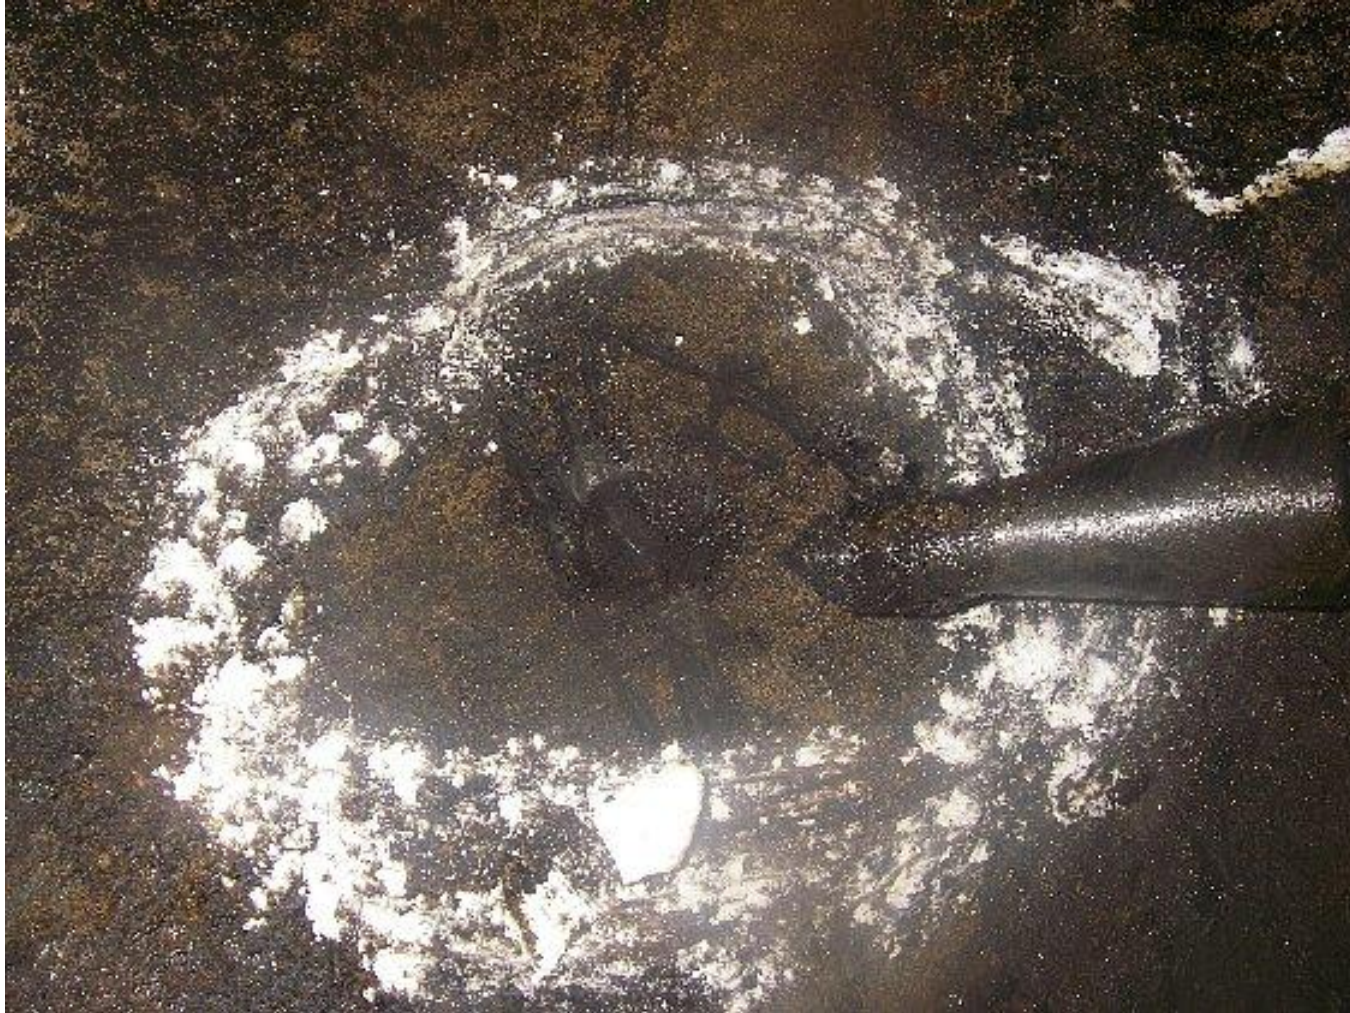
# **Pit with Maximum Depth(5mm) After 15 years-Service**

# Pit with Maximum Depth(5mm) After 15 Years-Service

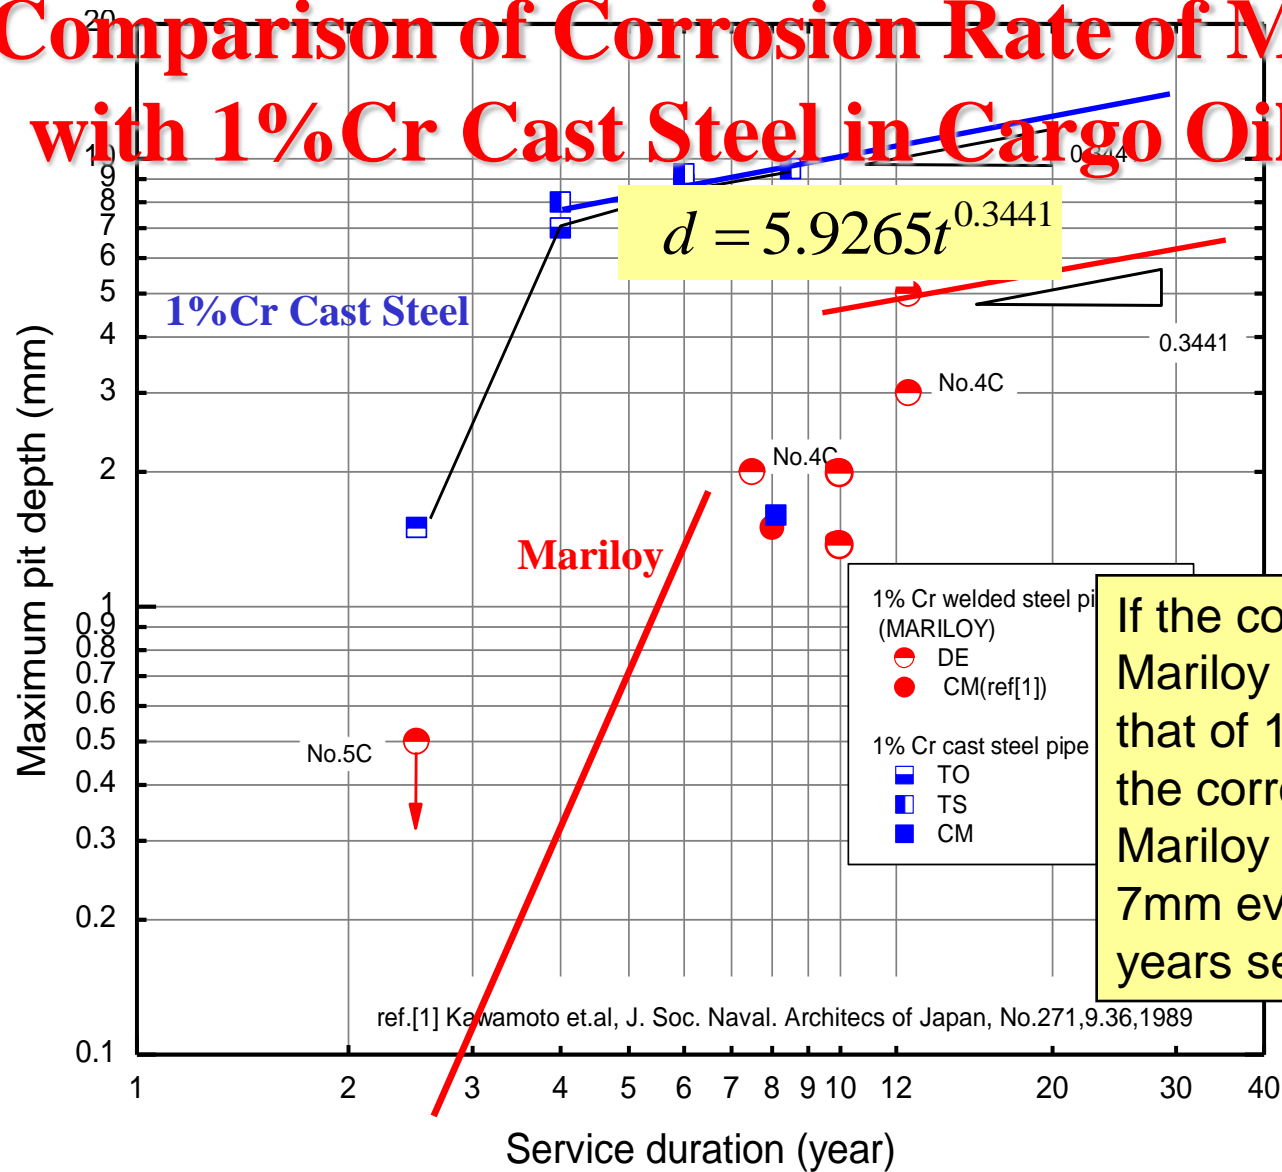
# Comparison of Corrosion Rate of Mariloy with 1%Cr Cast Steel in Cargo Oil Pipe

If the corrosion rate of Mariloy is the same as that of 1%Cr cast steel, the corrosion depth of Mariloy is less than 7mm even after 30-years service.

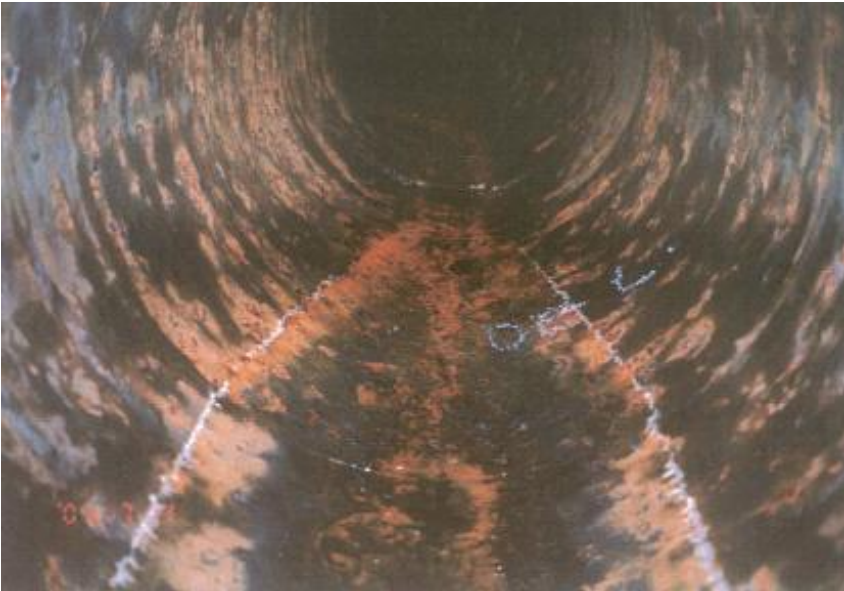
**After 7.5 years (Water ballast pipe in pump room)**

About a half of surface was covered with rust and the other half was covered with mill scale.

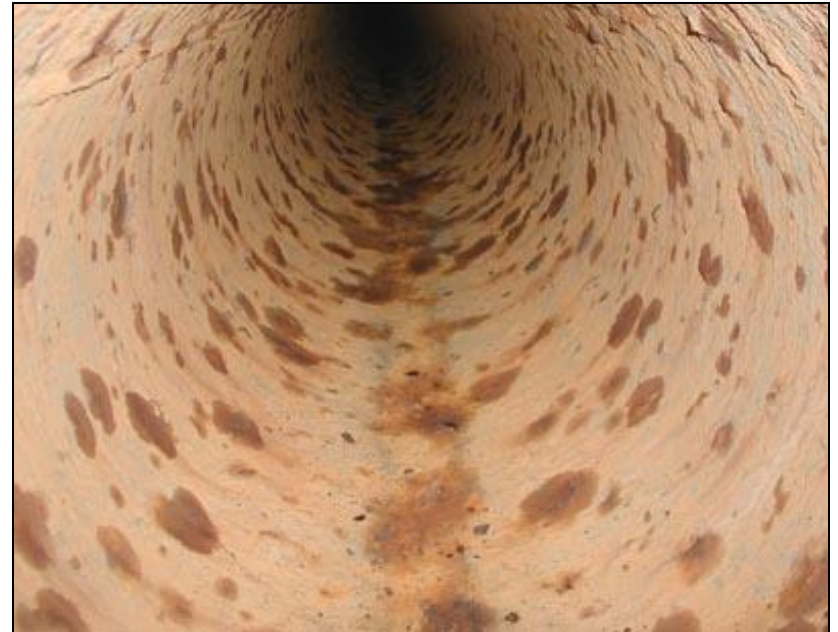
**After 12.5 years (Water ballast pipe in cargo oil tank)**

The surface was fully covered with rust. Dark spots were wet portion.

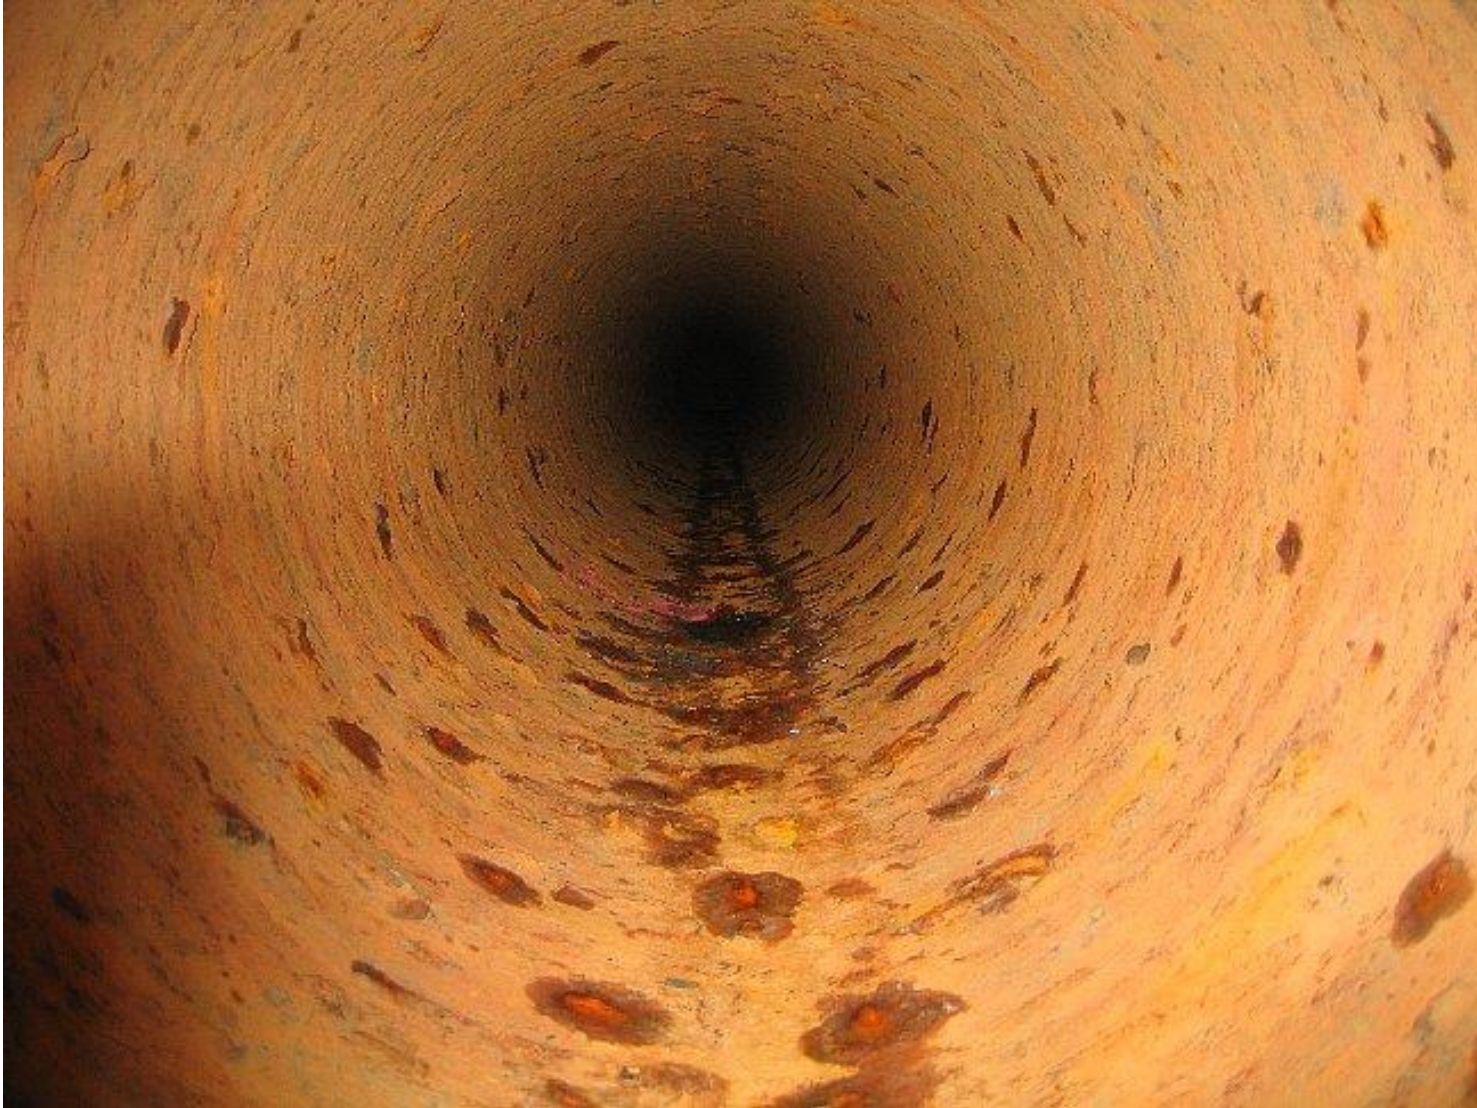
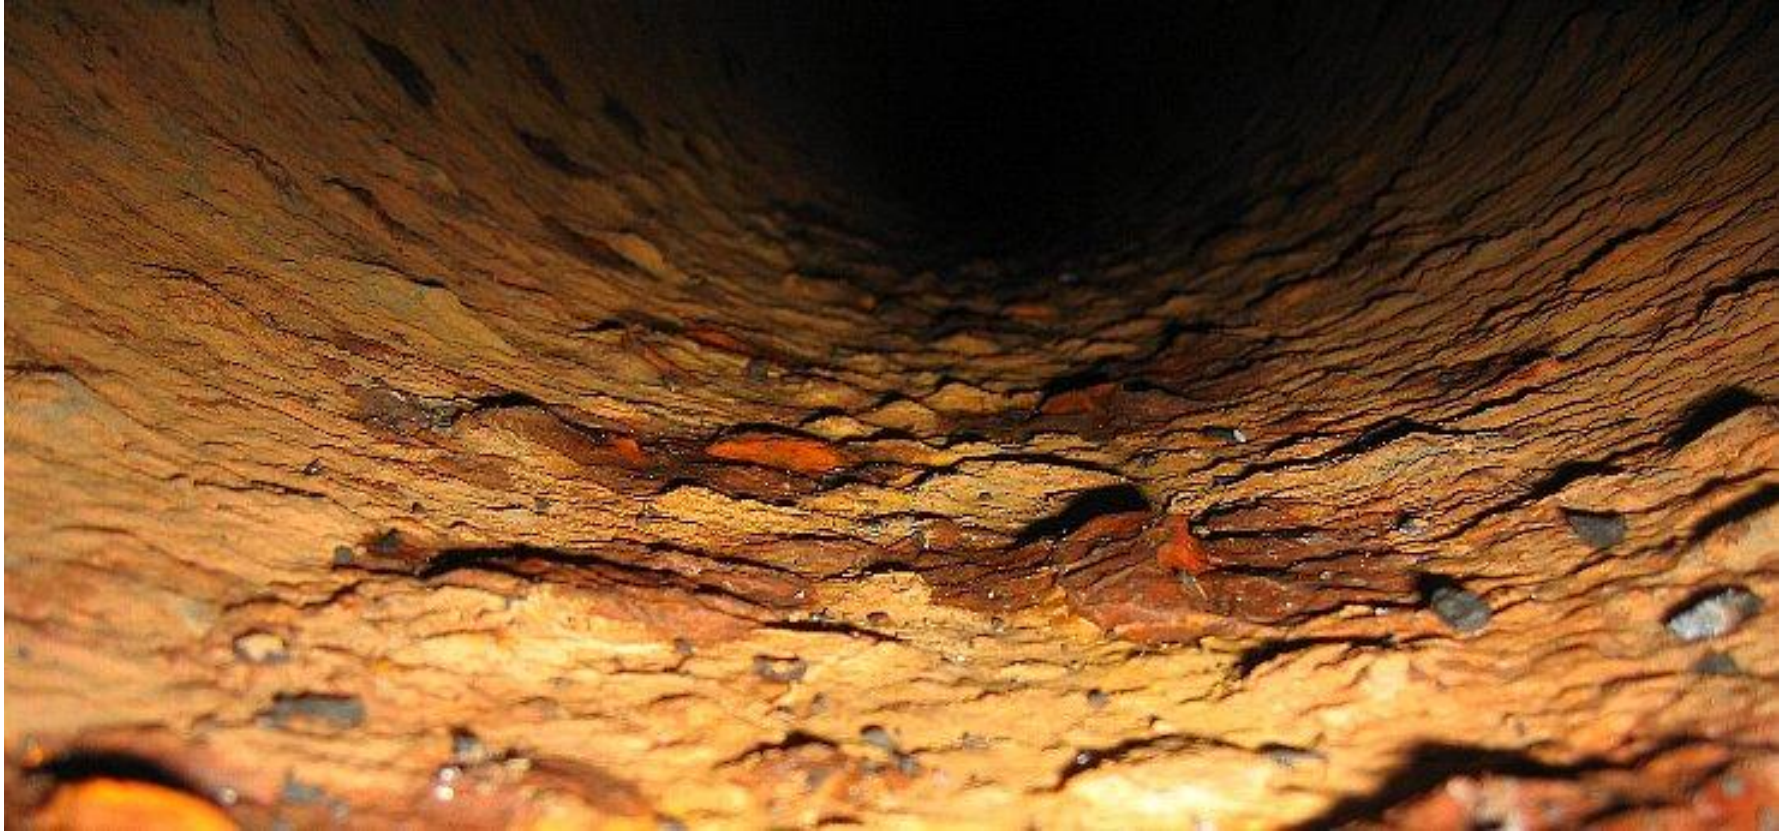
# Inside of Water Ballast Pipe After 15 Years

There is no pit in the inside of water ballast pipe, though all surfaces rusted. That means that general corrosion occurred.

As the maximum loss in wall thickness is 3.2mm maximum after 15 years, Mariloy can be used without painting over 30 years also [in water ballast pipe environment](#).

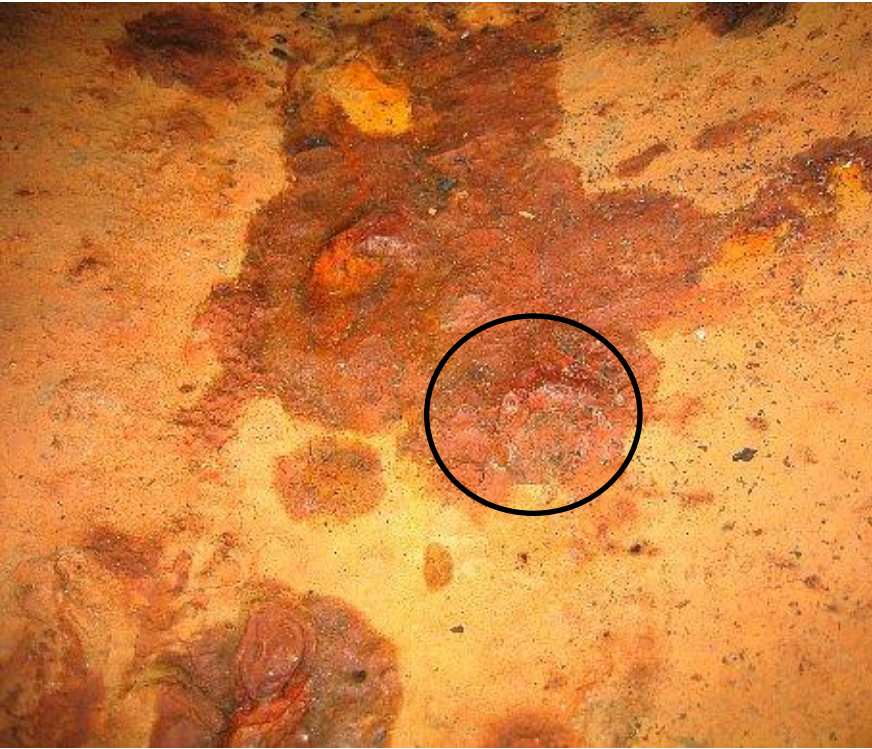
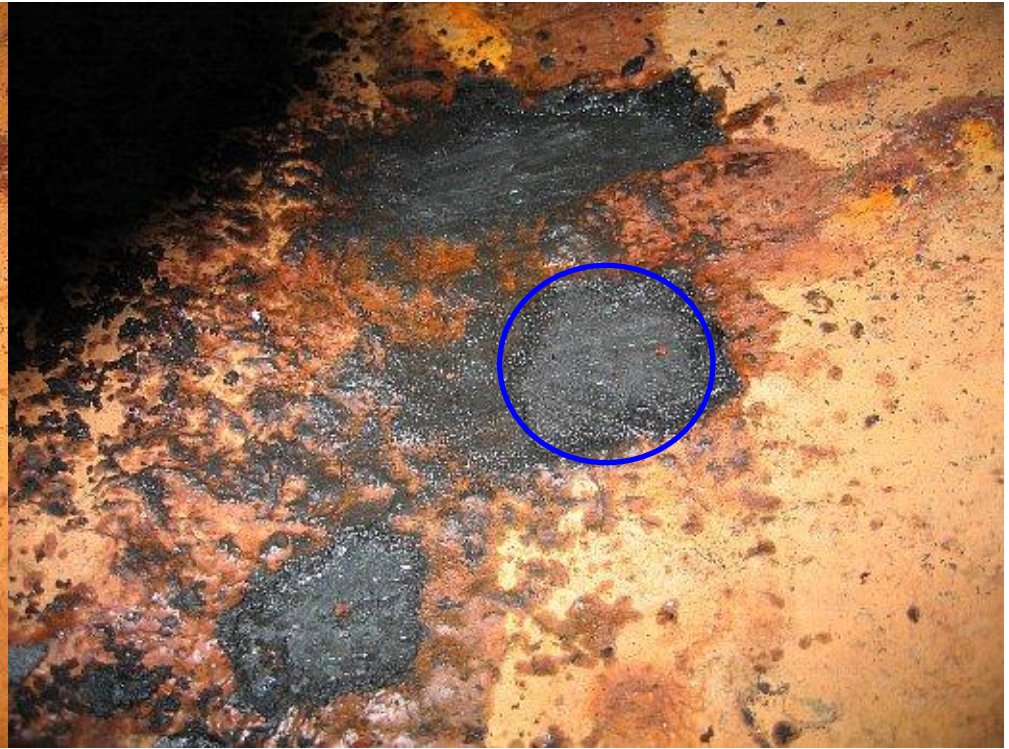
Before Hammering

After Hammering

There is no pit under the rust; General Corrosion

Ultrasonic measurement of wall thickness: max. 3.2mm loss
